Technical Note N-1284

ANALYSIS OF THE CONDITION OF ECHO TOWER,  
AZORES FIXED ACOUSTIC RANGE, AFTER ONE  
YEAR AT 1500 FEET OF DEPTH

May 1973

Naval Civil Engineering Laboratory  
Port Hueneme, California 93043

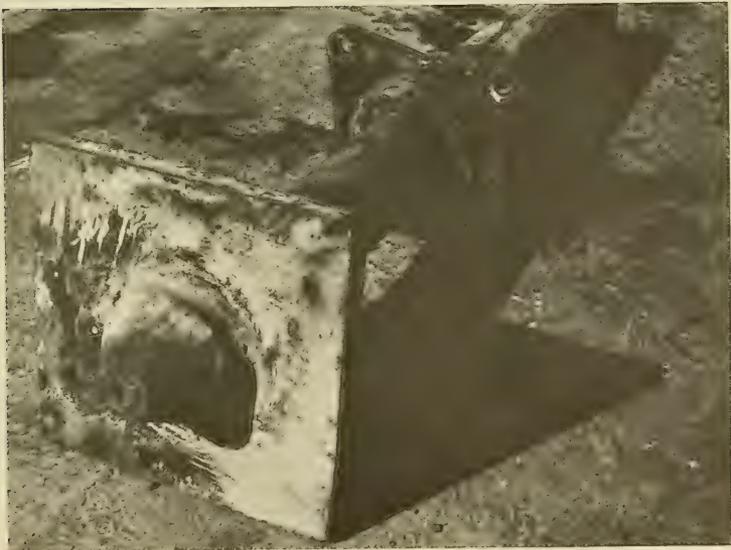
The shock absorbers, as shown in Figure 3, were covered with loose, flaky red rust and rust stains. The surfaces under the rust were etched but no pitting was noted. The area under the missing hardened tip was as corroded as the adjacent areas on the cone, which indicates that the hardened tips were lost during emplacement. Areas under the undamaged paint coating were unattacked. The paint coatings showed no undercutting adjacent to damaged areas.

Figure 3. Shock Absorber.

Echo tower was to be reemplaced if its condition permitted. As the damage resulting from emplacement and retrieval was minimal and the amount of corrosion found did not preclude reemplacement, the tower was repaired. The four shock absorbers were replaced with similar units. However, the tips on these units were screwed into place in contrast to the pressed-in units originally used. These screwed-in tips were further secured by welding and are shown in Figure 17. The universal joint was relubricated. The tower base, universal joint, main column and buoyancy sphere were cleaned by an air powered high pressure water jet and recoated with a copper oxide-pigmented rubber-based antifouling topcoat. The yellow enamel identifying marks were reapplied after the antifouling coat had cured. The condition of the buoyancy sphere after repair is shown in Figure 18. The fasteners used to secure the cable conduit to the main column were recoated as required with a rubber based sealing compound. Rusted areas on the steering carriage and antenna support arms were cleaned and recoated with a two coat, polyamide-cured epoxy paint system. The gas generators were replaced. The attacked areas on the antennas were carefully sanded and cleaned before recoating with the same paint system. The gas connections between the ends of the compliant tubes and the gas manifolds were cleaned, the clamps and tubing replaced as necessary and recoated with a two component sealing compound where any rust staining of the connections was noted. Areas of paint failure on the foam tower were repaired using the topcoat of the polyamide cured epoxy paint system. Identifying marks were reapplied to the foam tower. The recoated foam tower is shown in Figure 19. The main lifting eye was cleaned, and then recoated with the two coat polyamide cured epoxy system. The tower was then considered to be ready for reemplacement.

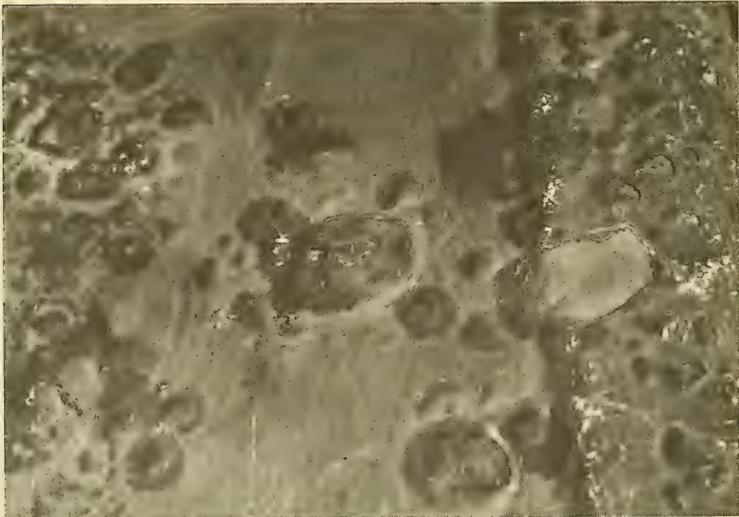
Figure 5. Blisters on steering carriage.

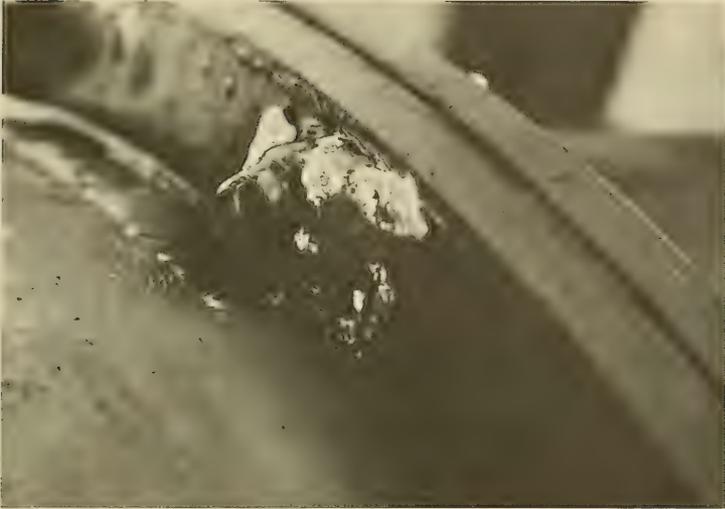
Figure 6. Fastener on carriage stop housing flange.

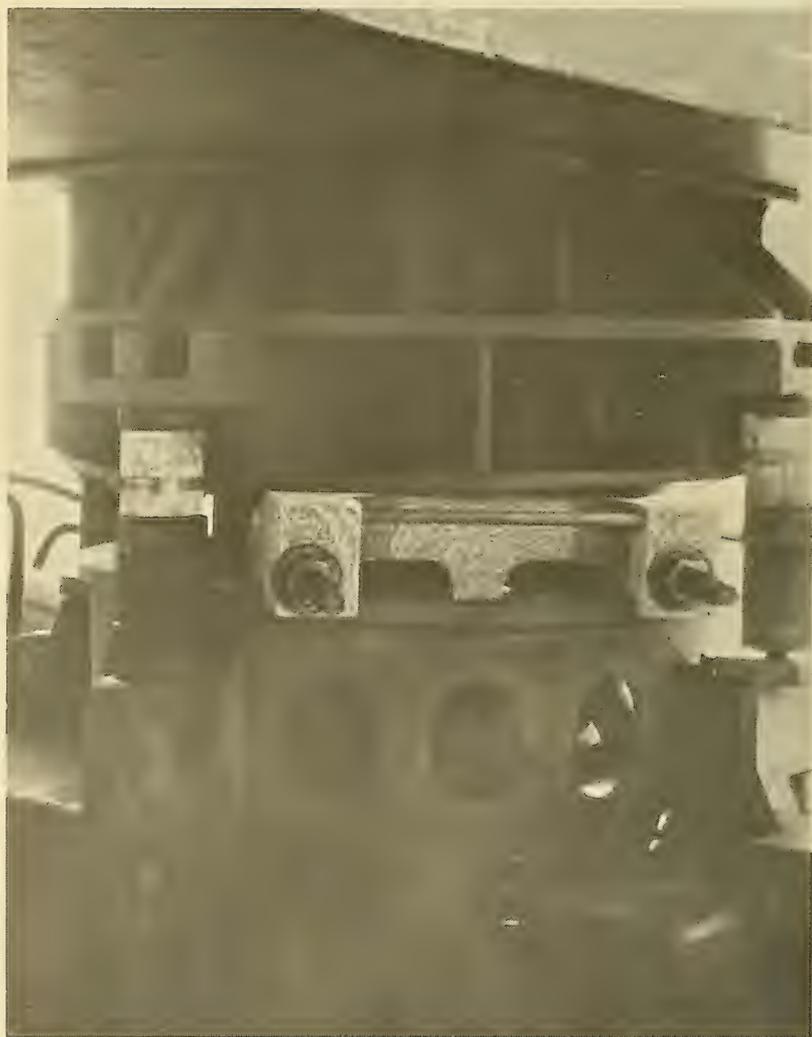
Aluminum alloy keys and jacks were attached to the steering carriage after recovery in order to secure the antennas during the tow. After five days exposure these keys and jacks were covered with a rather thick coating of corrosion products. This attack was due to galvanic corrosion between the keys and jacks and the exposed steel areas on the tower.

Figure 8. Carriage lock keys and jacks.

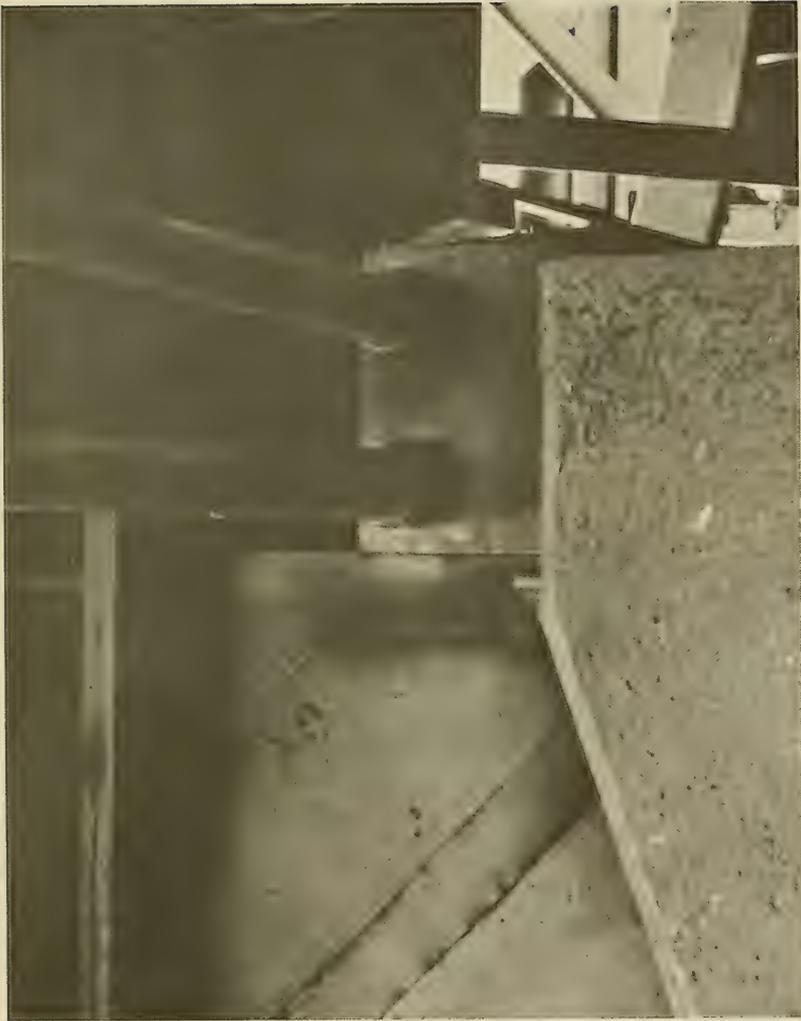
The gas generator support structure, as shown in Figure 9, had loose flaky red rust at the edges of the metal frame members. Only superficial corrosion was found associated with this rusting. The titanium cathode on the electrolytic generator, as shown in Figure 10, was unattacked. The platinum anode was also unattacked. The remaining fouling on the platinum anode was easily removed by fresh water rinsing.

Figure 9. Gas generator support structure.

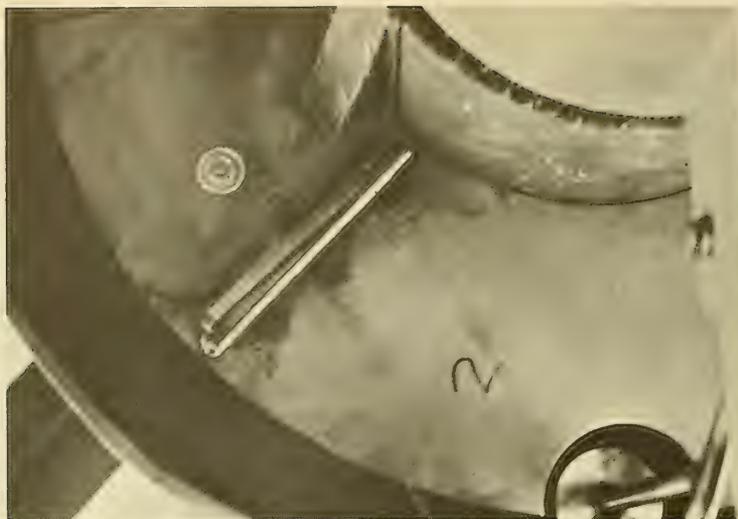
Figure 10. Electrolytic gas generator cathode.

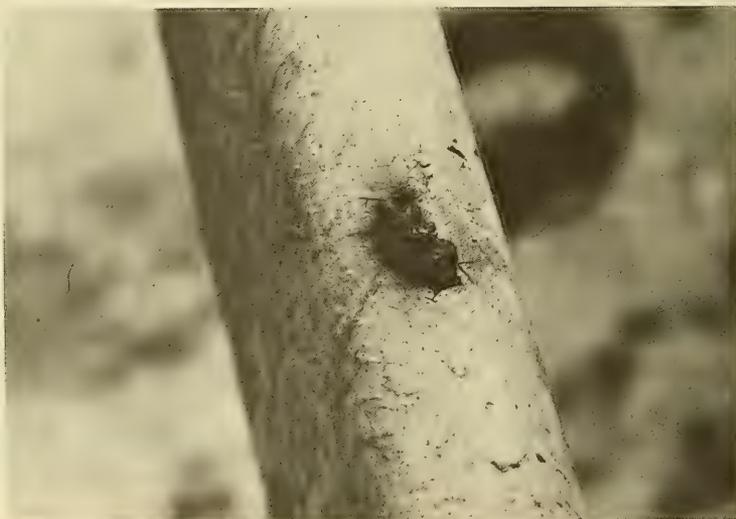
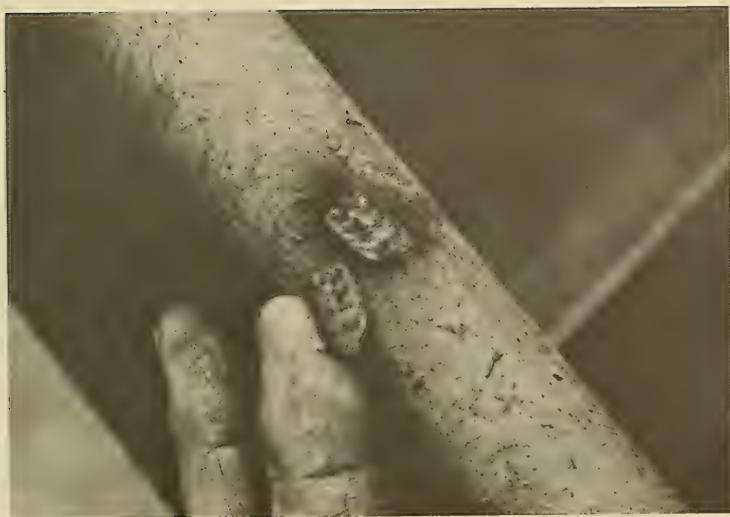
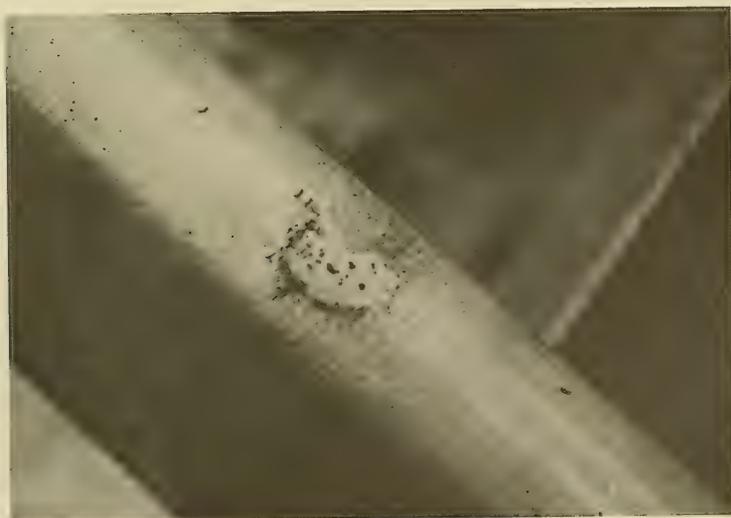
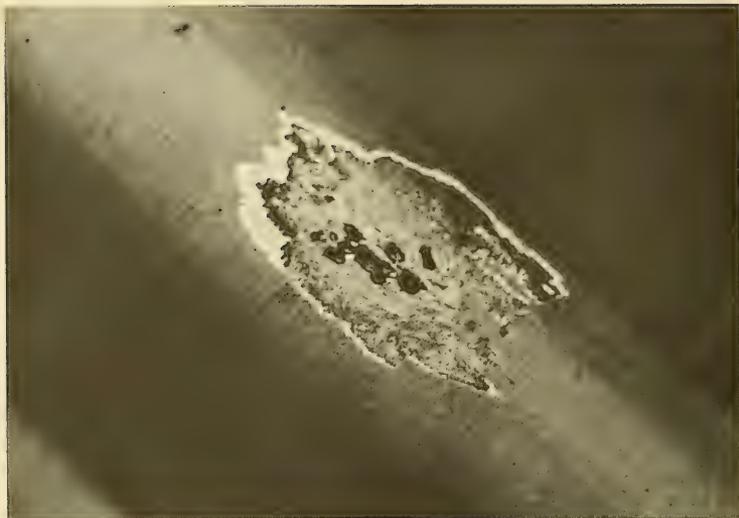
Figures 11 through 14 show the results of inspection of a typical rusted area on the middle frequency antenna. Figure 11 shows the area covered with a loose flaky red rust deposit. Figure 12 shows the area after removal of the deposit. Figure 13 shows the defects in the coating which resulted in the attack. Figure 14 shows the area after removing the coating. Note the feathered edge of the coating in Figure 14. Only three coats of paint are present. A red primer, white second coat and gray topcoat. No zinc rich primer was used on this or any other rusted areas of the compliant tubes. Brushmarks in the coatings at the rusted areas indicated that the coatings had been "touched up" at these locations without using the zinc rich primer. Removal of the upper coats of paint in an unattacked area of the low frequency antenna showed that the zinc rich primer was present.

Figure 11. Rusted area of middle frequency antenna.

Figure 12. Area shown in Figure II with rust removed.

Figure 13. Same area as in Figure II with rust staining removed.

Figure 14. Same area as in Figure 11 with coating removed.

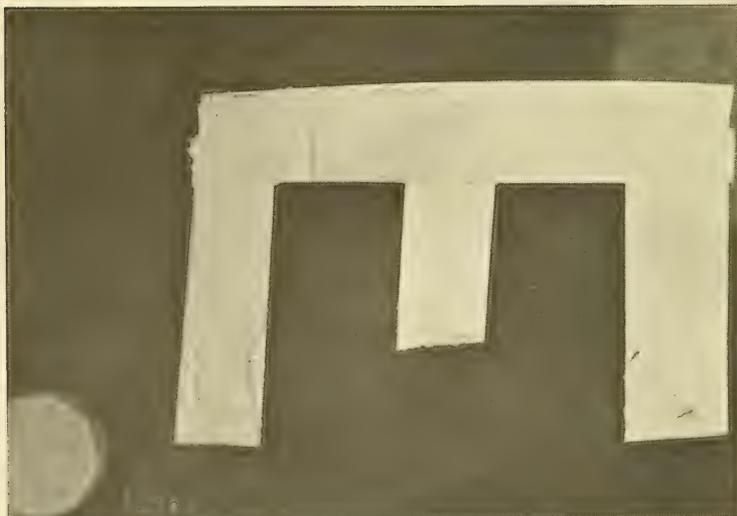
The condition of the syntactic foam blocks of the foam tower is illustrated in Figure 15. Although the coating at the identifying letter had failed, the underlying material was unattacked. No signs of water absorption or deformation of the foam blocks of the foam tower, low frequency antenna or gas generator support was noted. The main lifting eye at the top of the foam tower, as shown in Figure 16, was covered with a thin film of loose flaky red rust but no significant corrosion was noted underneath the rust layer.

Figure 15. Portion of foam tower.

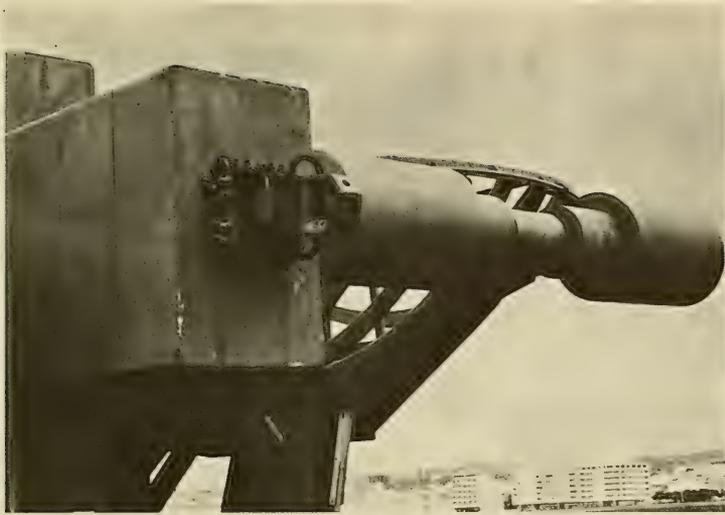
Figure 16. Main lifting eye at top of foam tower.

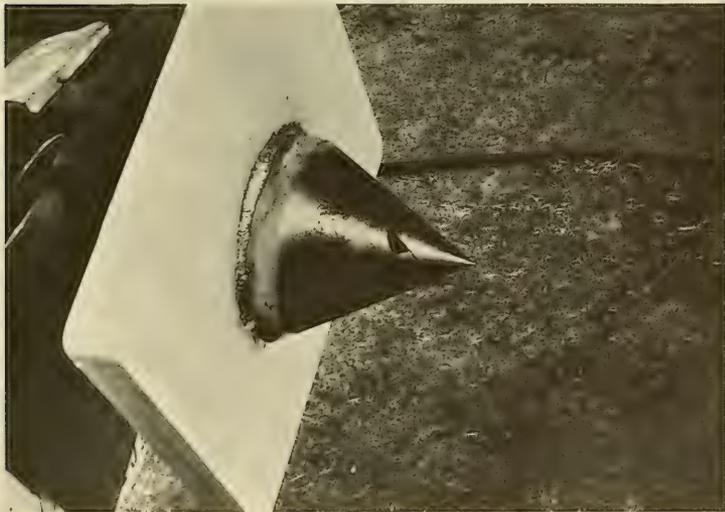
Figure 17. Modified shock absorber tip.
